Using ICP scan analysis as a powerful diagnostic and troubleshooting tool in analytical laboratories

Aristos Loucaides^a, Niki Wilkinson^b, Giannis Papageorgiou^c, Christie Stylianou^d, Louisa Christodoulou^e

a, b, c, d, e Aristos Loucaides Chemical Laboratory Ltd, P.O. Box 20379, CY-2151, Nicosia, Cyprus; email – info@arislab.com

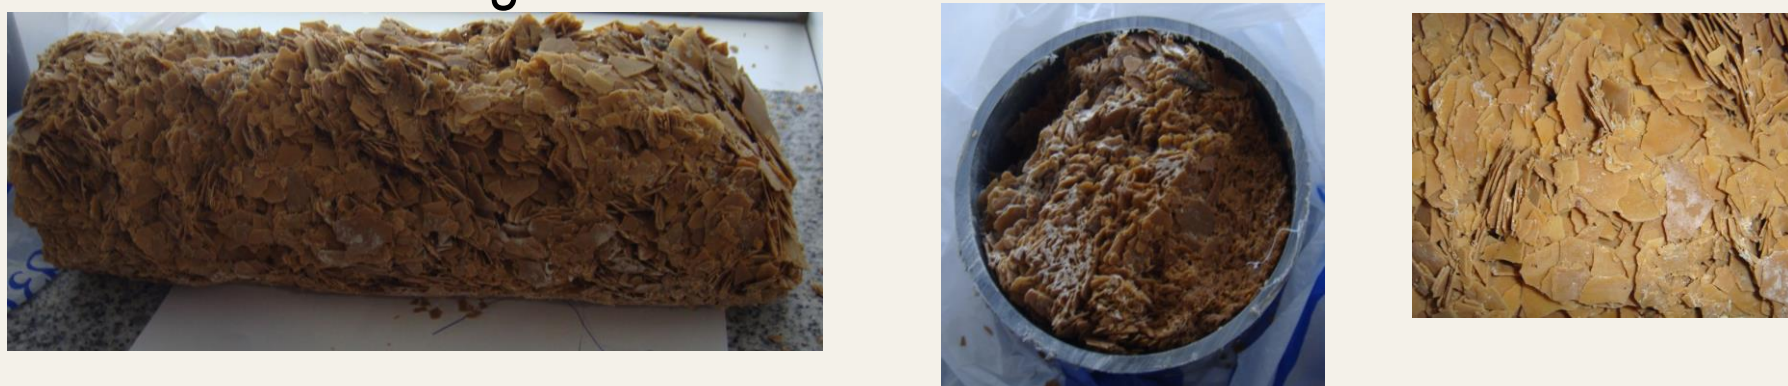
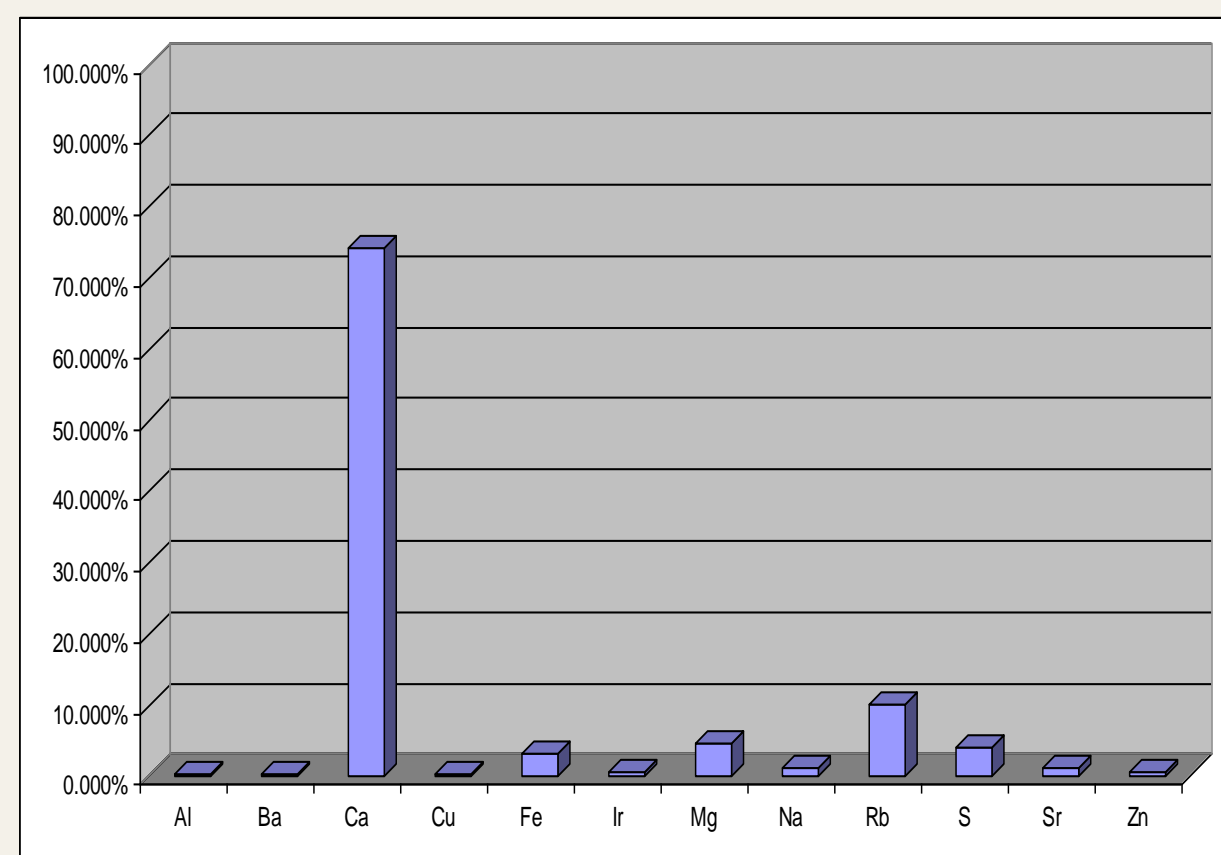
A typical example of a blocked pipe section is shown below as well as the subsequent results of the ICP scan analysis on the residue that caused the blockage.

Excessive scale deposition is confirmed to be the cause of the blockage, possibly as carryovers from larger diameter pipes which were gradually concentrating in the restricted flow area. ICP scan verifies that the origin of the depositions is primarily limestone (CaCO₃) and also sulphate-based minerals to a smaller extent. There is also a clear indication of corrosion taking place within the distribution network (presence of iron and zinc) and of the alum-based flocculants used in the water refinery process.

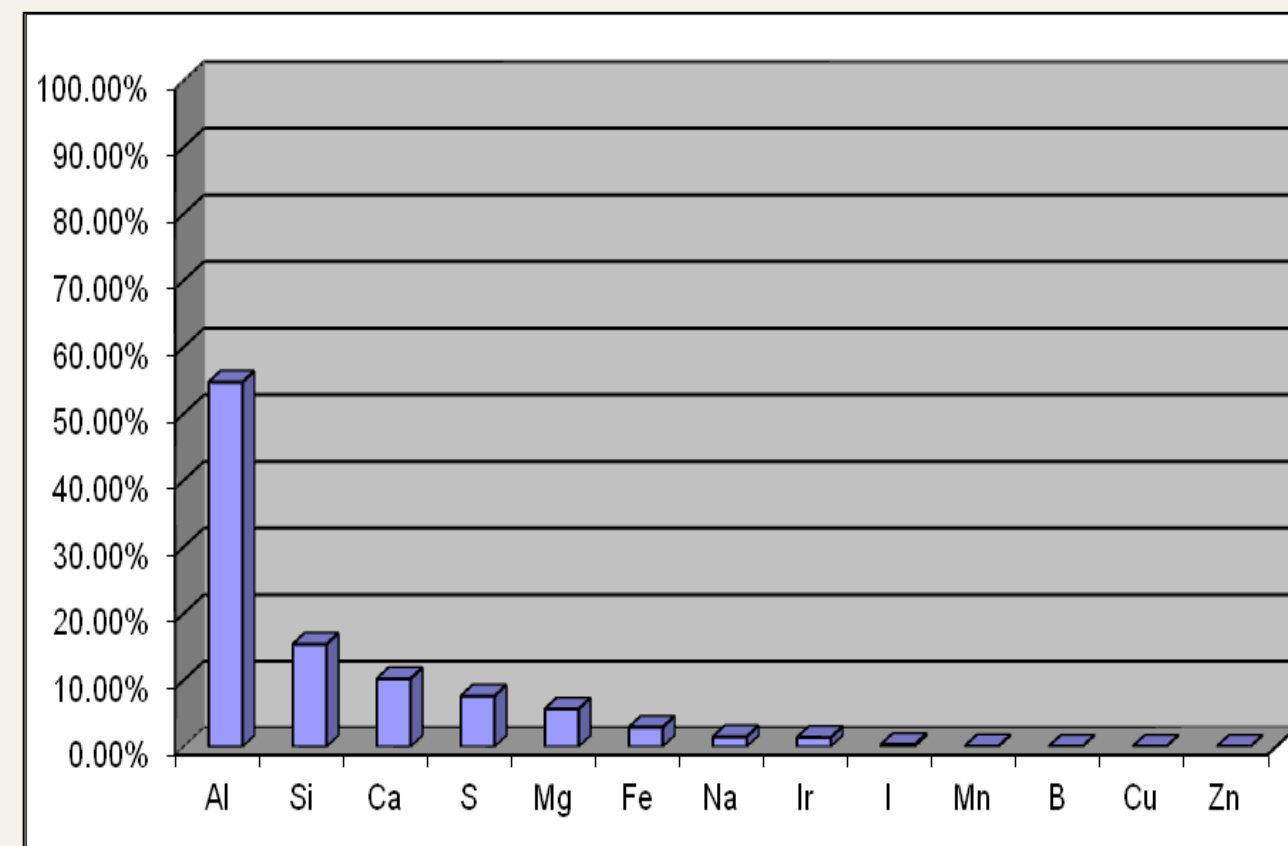
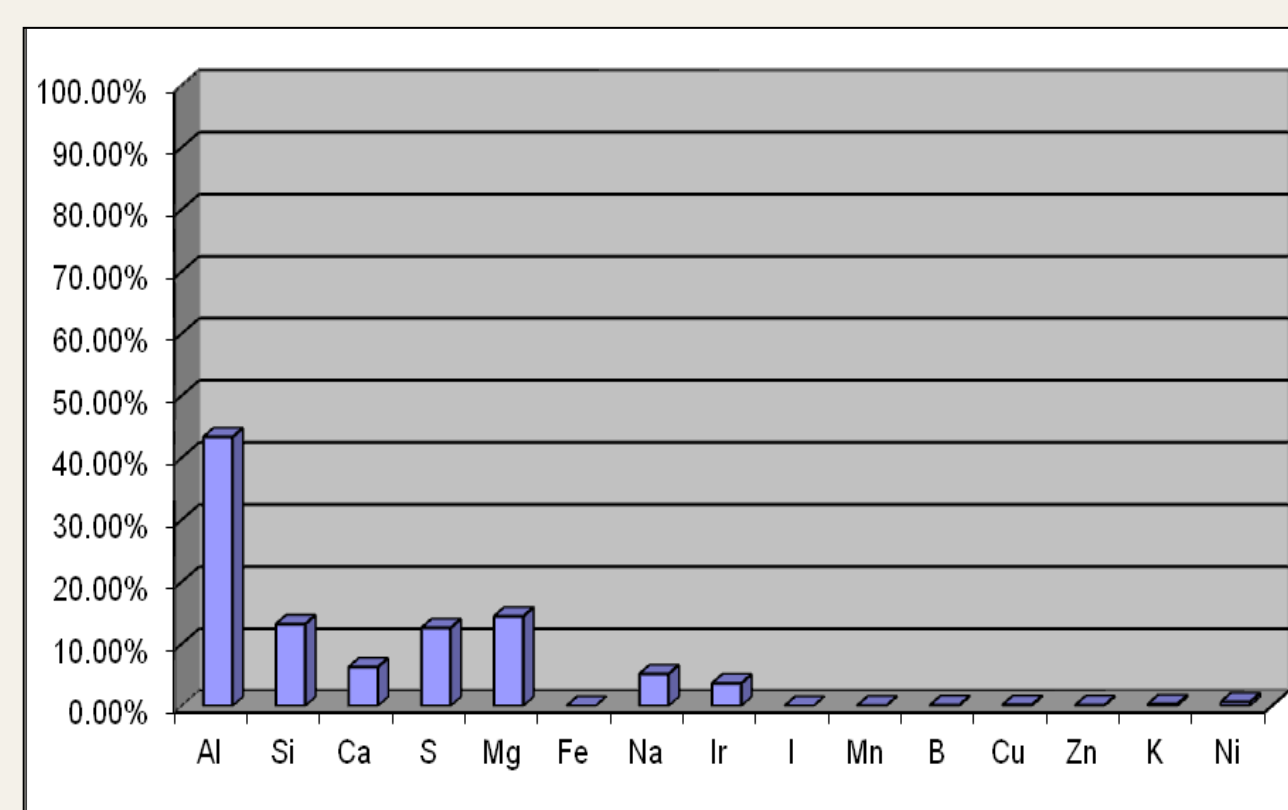
This investigation relates to sludge samples received from two separate water refinery plants in the course of optimising the dosing of flocculants, following elevated aluminium findings in mains water supplies (150 – 250 ppb against the regulated limit of 200ppb).

It is evident that both refineries had been using the flocculant (alum sulphate at the time) in excess, with no optimisation on the dosing. As a result of this study, an alternative chemical was introduced (PAC). This proved to be equally effective, with lower aluminium content.

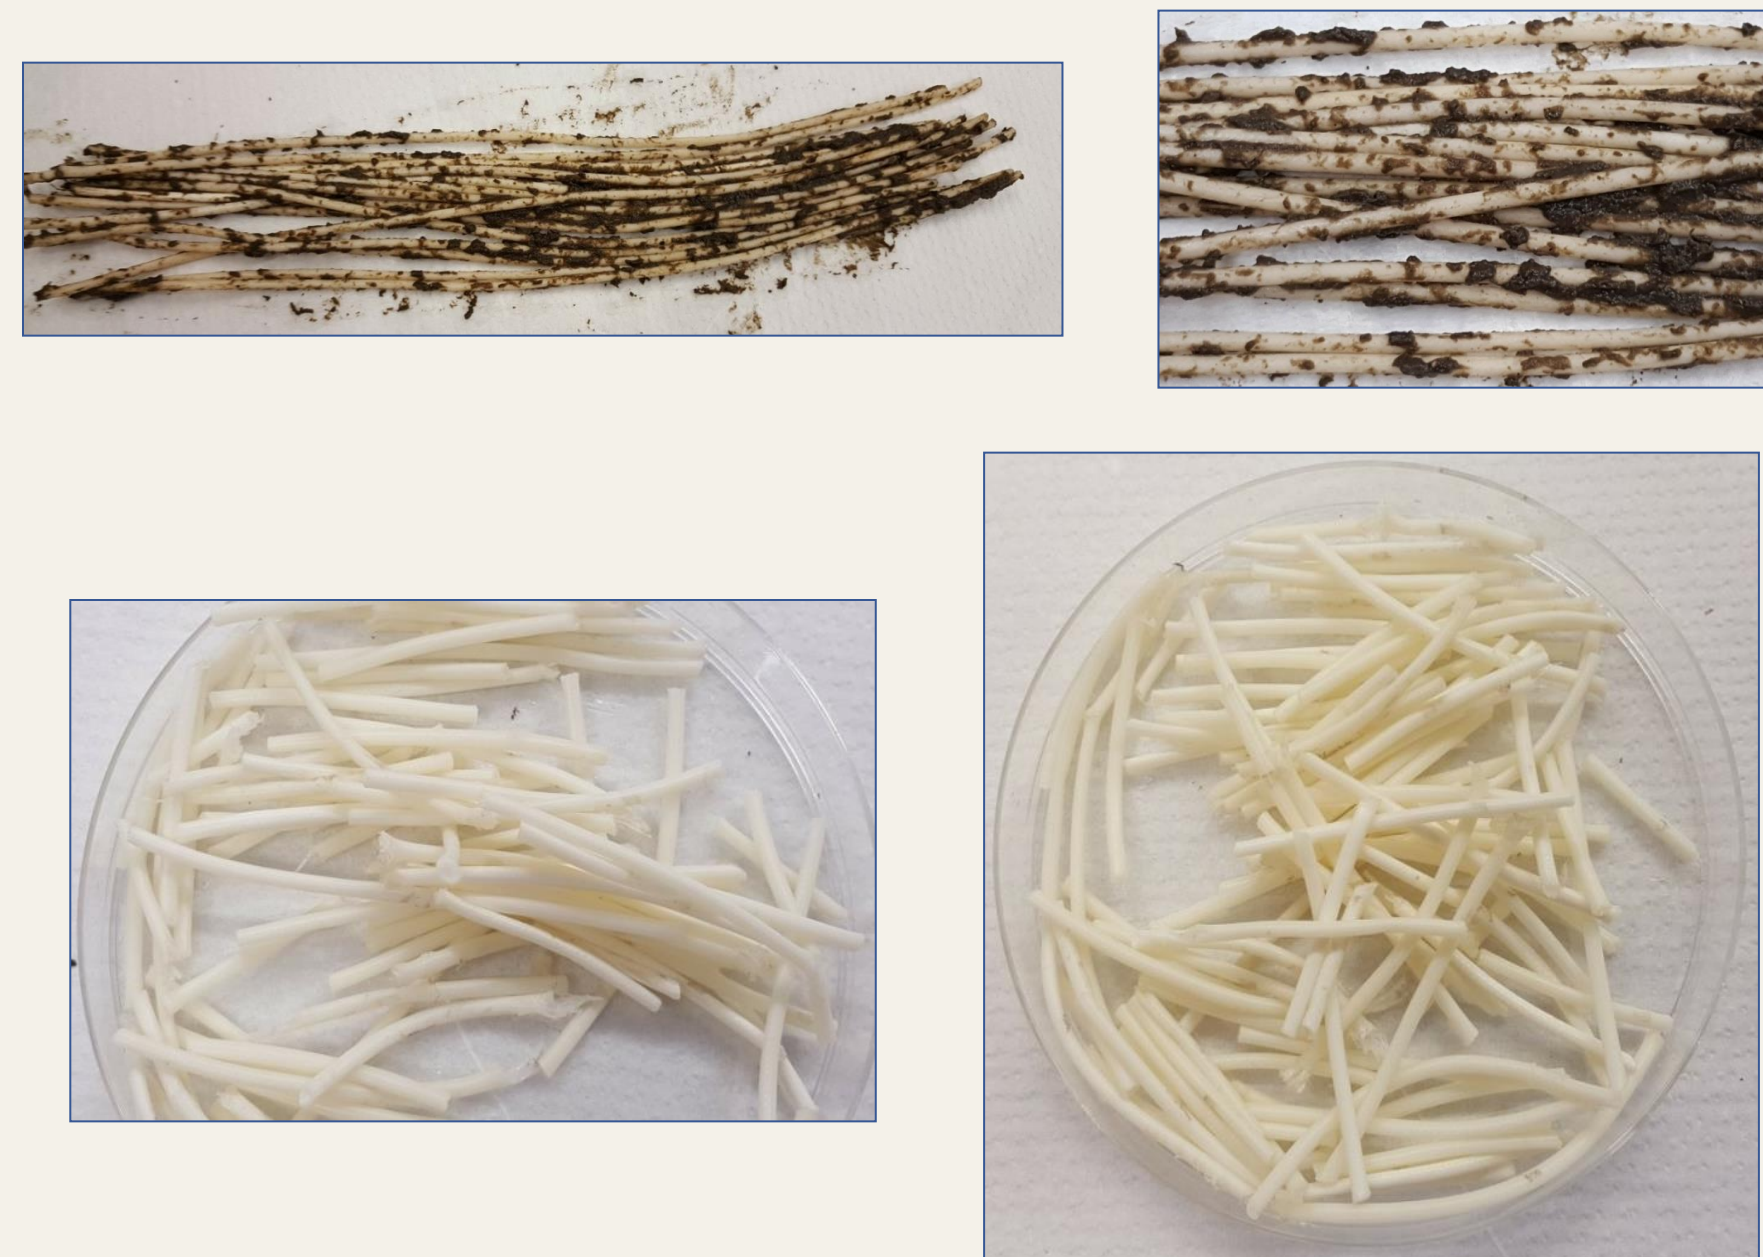
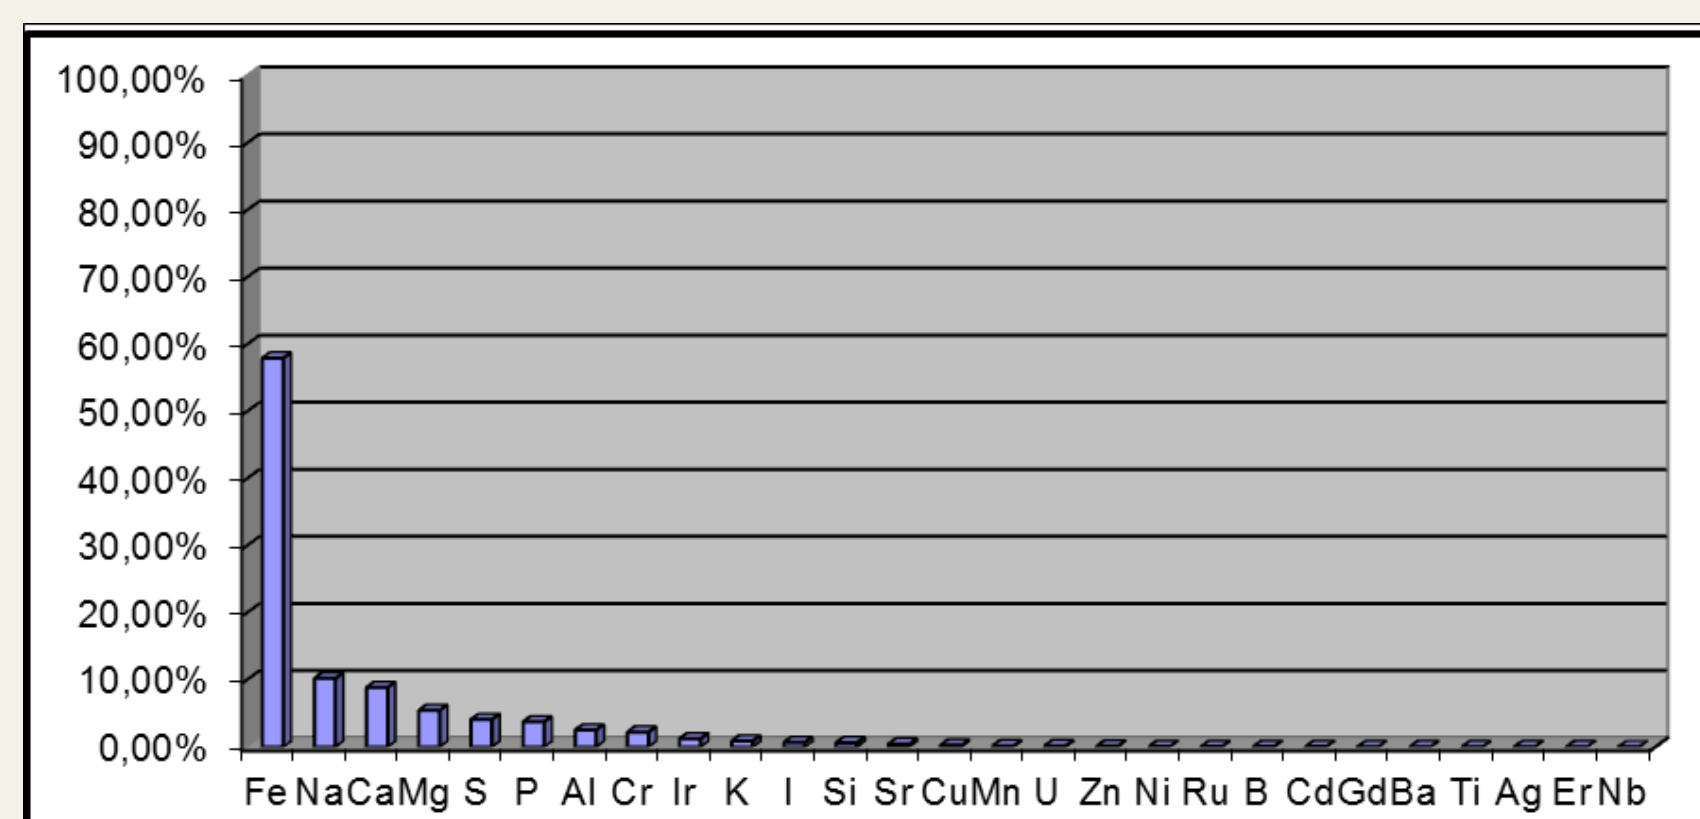
In the process of investigation, hollow-fibre membrane sections were delivered to the lab for analysis, as shown below (before & after sample preparation).

The quality of the mains supply in the district where this STP operates was raising concerns that this might be caused by excessive scale deposition on the membranes. The ICP scan had actually revealed another source of concern which seemed to be linked with the ferrous chloride used as a flocculant/coagulant in the primary treatment section of the station.

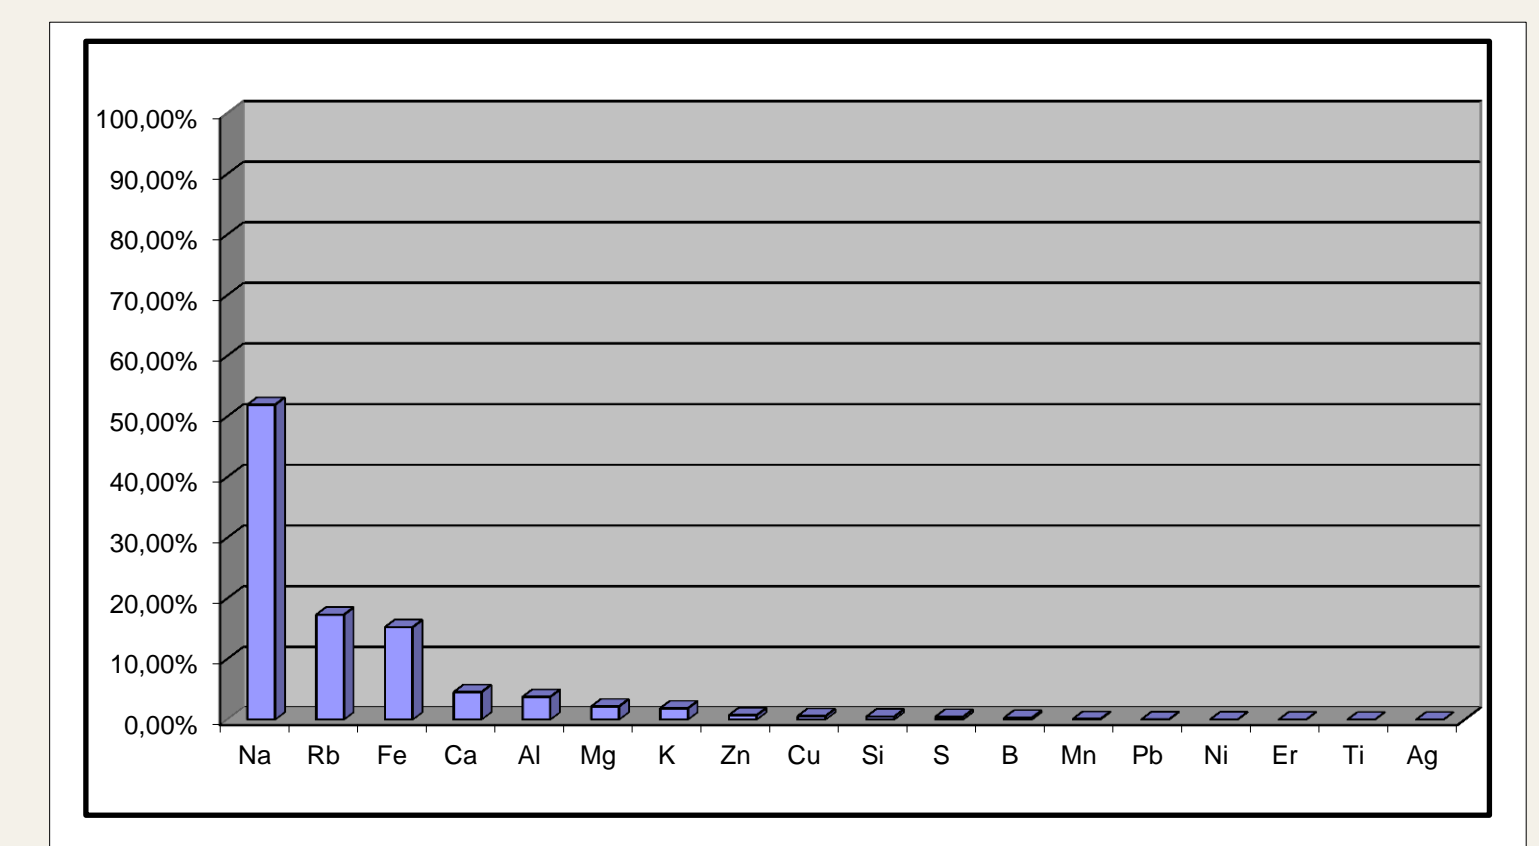
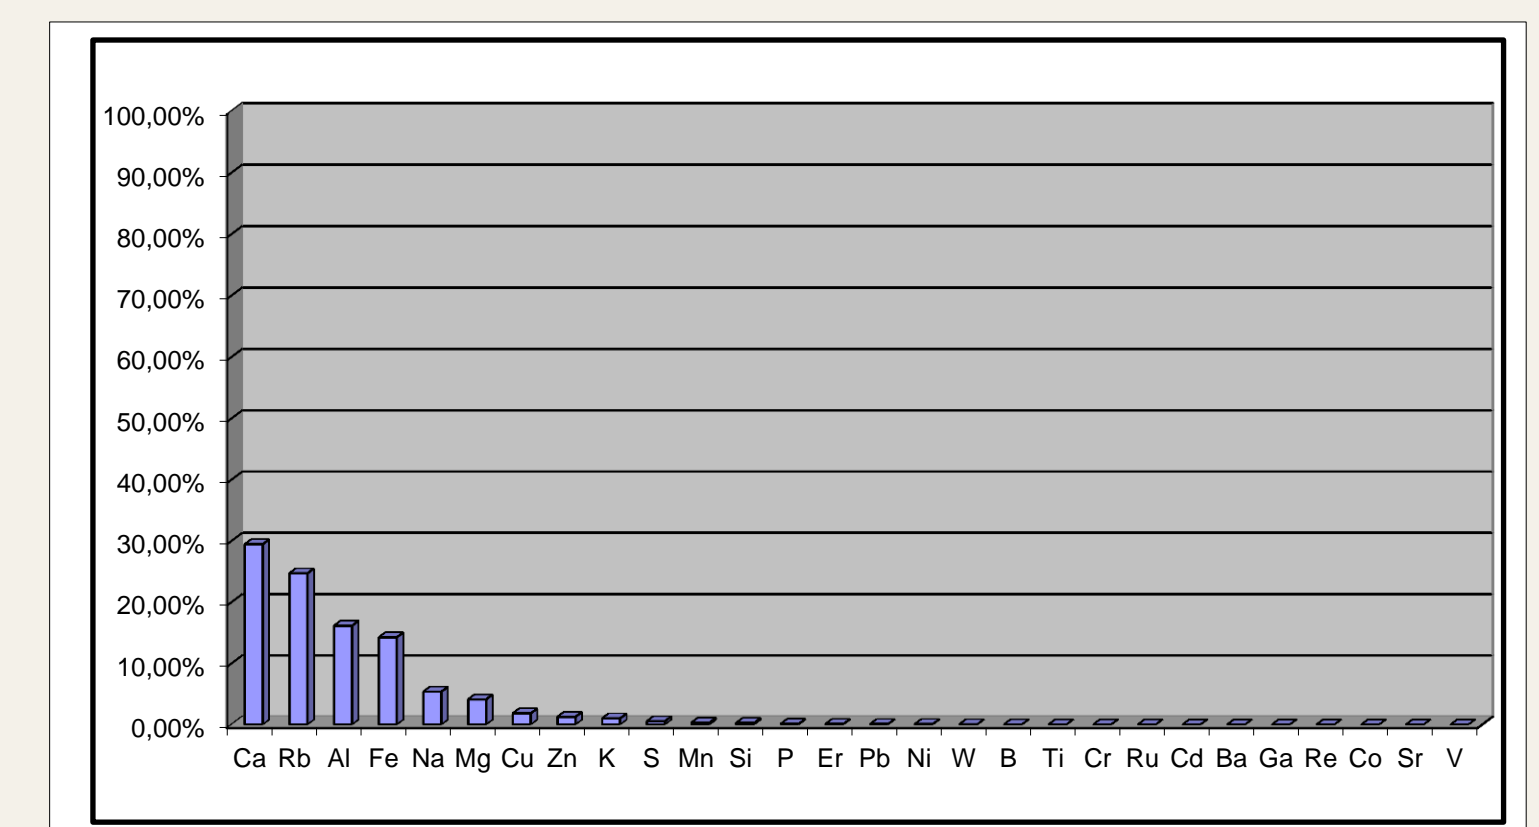
A seaside holiday residence was experiencing problems with highly coloured water in the mains supply. One water sample from the mains supply (roof storage tank) and one salts residue sample from the surface of the paved area cleaned with the mains water, were analyzed with results as shown.

The mains supply water indicates a SWRO plant product passing through a water refinery and exhibits a corrosive tendency, as indicated by the presence of iron. The salts residue composition shows the same origin, after weathering due to successive evaporation /concentration cycles.

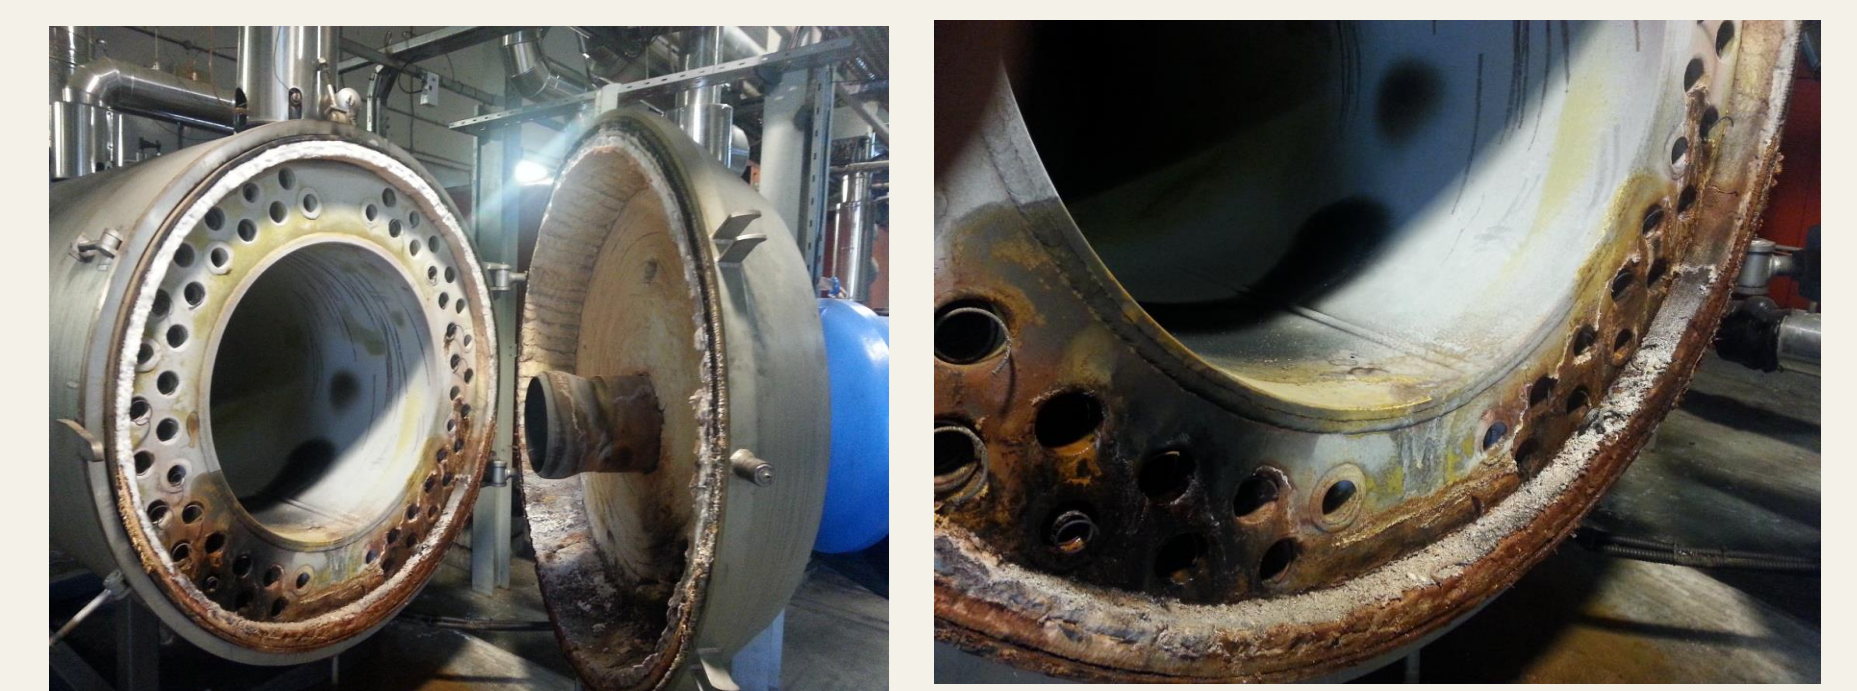
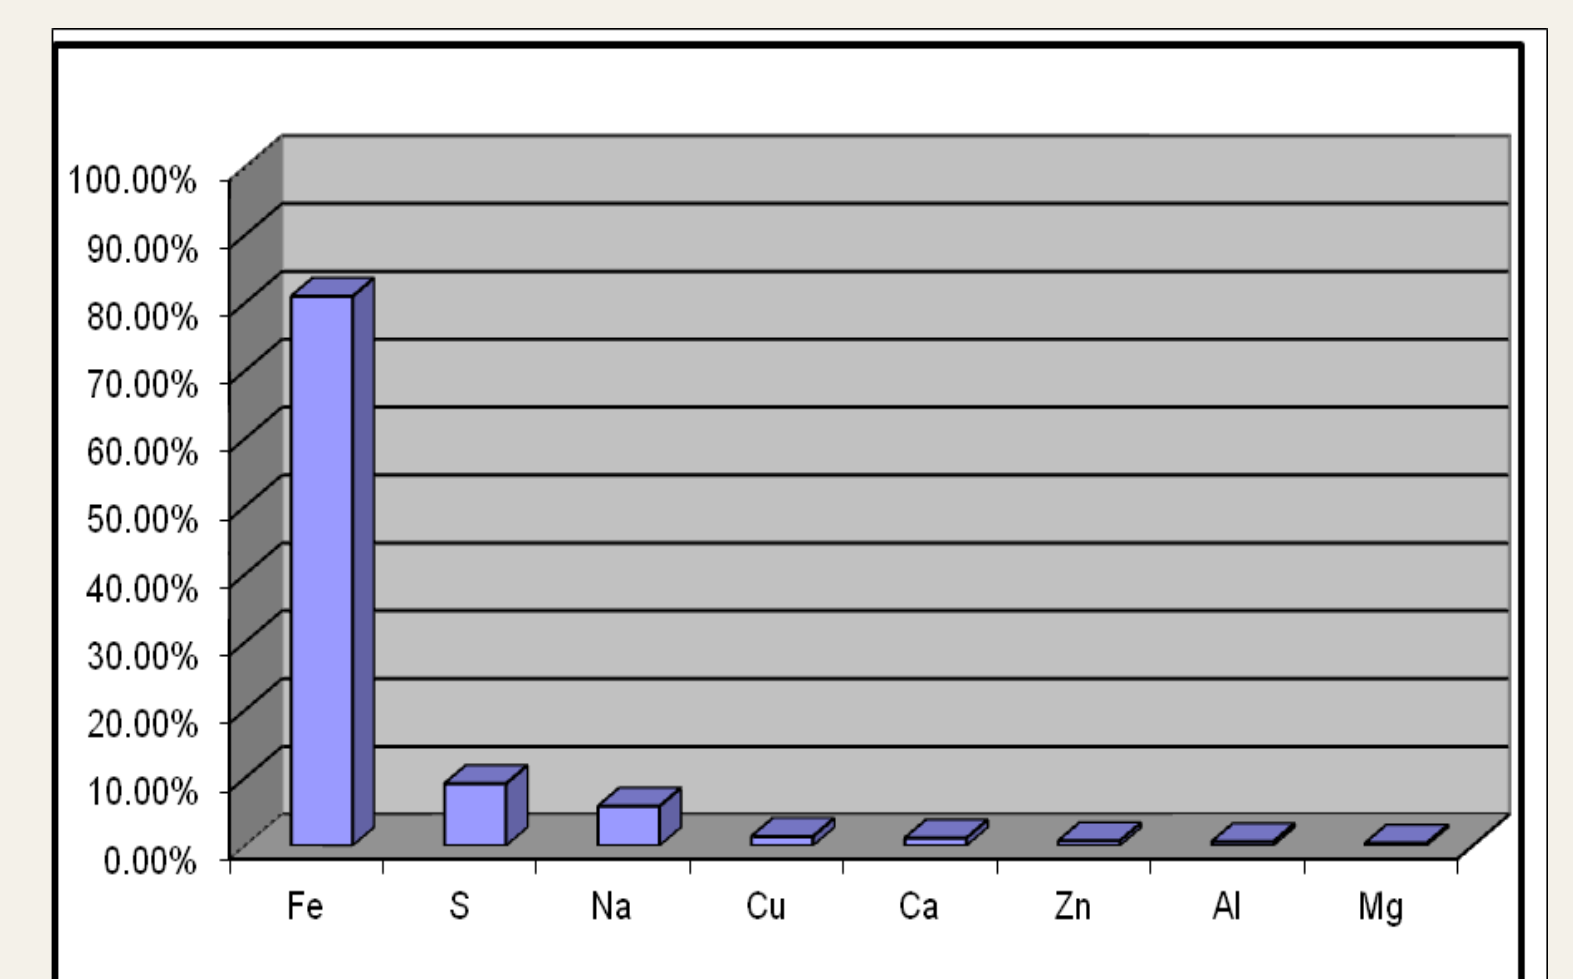
A firetube boiler failure at a large commercial complex comprising of offices and shops, was investigated. Salt deposits from the inner surface of the boiler near the areas of failure were examined in order to ascertain the real cause of the problem.

As expected, the predominant ion present was iron and also copper at lower levels, signifying excessive corrosion within the boiler. However, an additional indication was provided by the presence of sulfur which was suspected to be linked to the HFO used as a fuel. This might be a significant contributor to the corrosion observed as also verified by subsequent sulfur determination on the fuel which rendered sulfur results ranging between 2,5 – 3%.
